Environmental Impact Assessment

10566, 10582, 10620/10626 Scott Road Surrey, BC

Prepared for: Brunswick Property Holdings Ltd.

Project No.15934 April 22, 2022

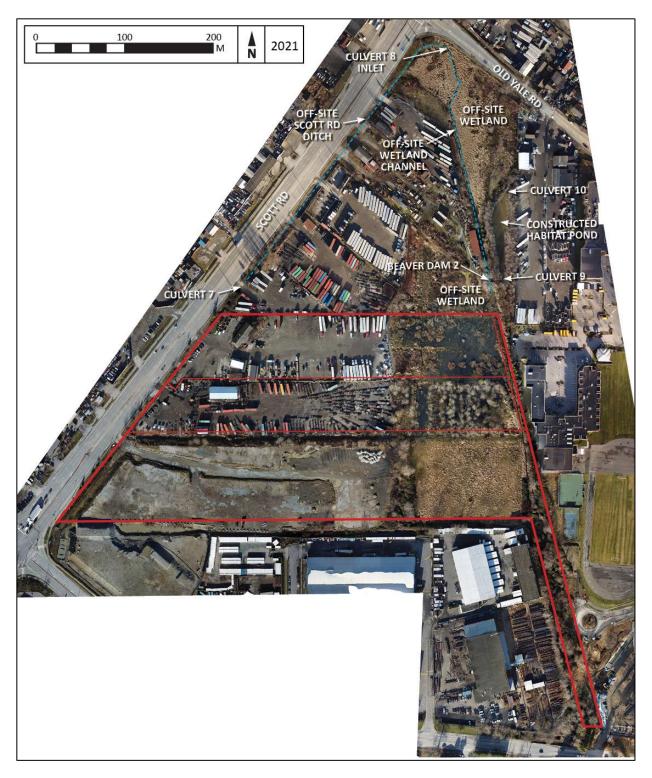
Figure AB-16: 2021 drone image of the Project Site (Base map source: Stirling Geoscience Ltd.)

A description of each of these features is provided in the following sections. The City of Surrey COSMOS aquatic mapping is provided in **Appendix E** (City of Surrey 2021); the municipal mapping is not considered reflective of existing field conditions. Current conditions of each of the features are shown on **Figure 4** and **Appendix B** Figure AB-16 using recent drone imagery. **Figure 4** shows the ID and aquatic area of each feature, and Figure AB-16 shows aerial imagery unobstructed without shading or labels.

South Stream 1 originates at the south end of the panhandle and conveys flow northwest towards Wetland A (**Photographs 5 and 6**; **Figure 4**; **Figure AB-16**, **Appendix B**). A south connection under 104 Avenue to Robson Creek was not observed, suggesting that 104 Avenue is the upstream terminus of the feature. Prior to the development of this area, Robson Creek may have naturally flowed north into South Stream 1; currently Robson Creek flows northwest, south of 103A Avenue, before joining Manson Canal, which flows northwest into the Fraser River.

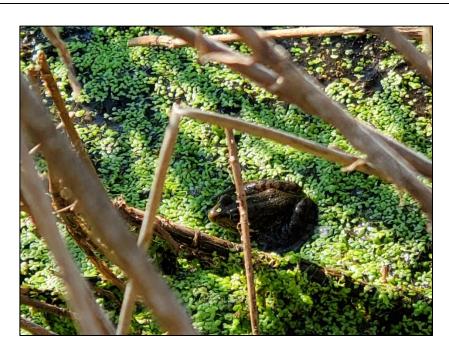
Photograph 3: View of a red-legged frog observed in Wetland D. Photograph taken September 4, 2020.

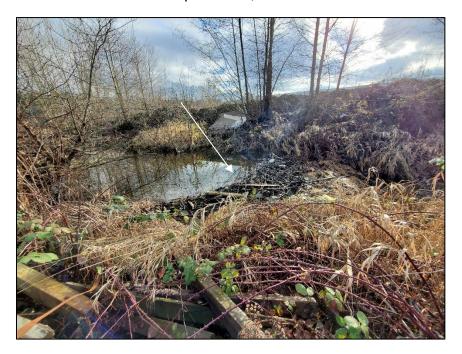
Photograph 4: Southeast view of Beaver Dam 1 near the eastern end of the Wetland Channel. The dam was constructed between the September 4, 2020 and December 23, 2020 field assessments. Photograph taken January 19, 2021.

Mammal observations included sign of American beaver (*Castor canadensis*) (i.e., chewings), primarily along the western edge of the wetland complex where a tree layer prevails. A recently constructed beaver dam was observed on the eastern edge of the Wetland Channel during the winter Site visits; the dam was not present in September 2020 (**Photograph 4, Appendix D**). Mule deer (*Odocoileus hemionus*) scat and beds were also noted throughout the wetland complex.

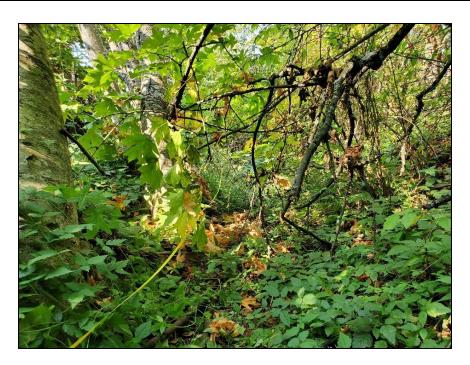
Photograph 5: Northward view of South Stream 1. The approximate channel midline is marked with the tape measure shown in the photograph. Photograph taken September 4, 2020.

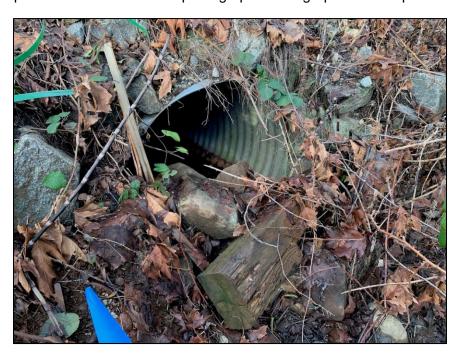
Photograph 6: Northward view of the inlet of Culvert 1. Culvert 1 is a 1200 mm corrugated steel pipe. Photograph taken January 19, 2021.

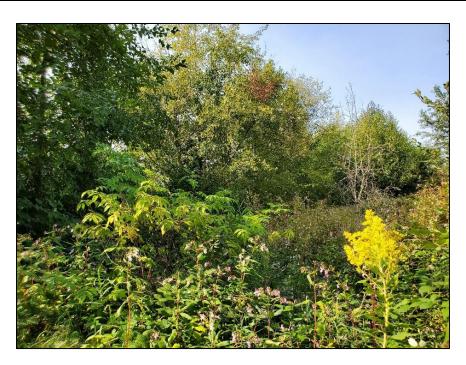
Photograph 7. Northwestern view across Wetland A during summer conditions. Photograph taken September 4, 2020.

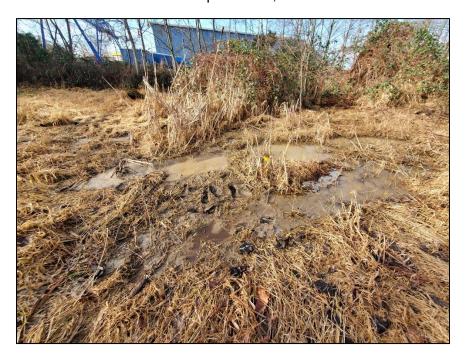
Photograph 8. Westward view across Wetland A during winter conditions. Photograph taken January 19, 2021. The silt deposited in the wetland (shown in the middle of the photo) is due to runoff from the upslope development shown in Photograph 10.

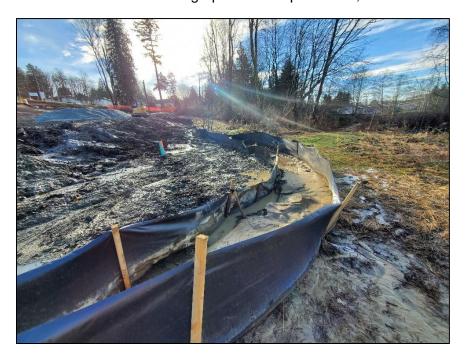
Photograph 10. Southward view of the conditions east of Wetland A where a residential development is under construction. Photograph taken January 19, 2021. The silt fences are intended to prevent further sediment from entering the wetland as shown in Photograph 8.

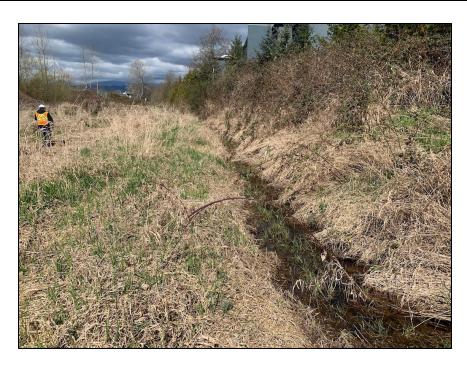
Photograph 15. Northward view across Wetland B near the eastern edge showing the weakly channelized portion of the wetland. Photograph taken April 8, 2021.

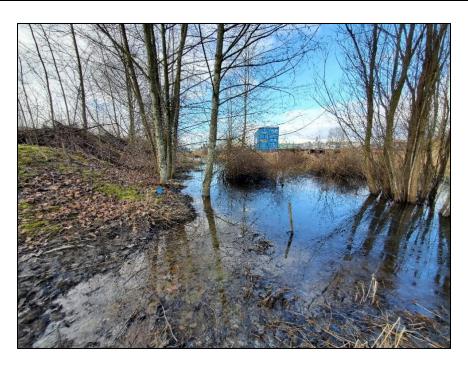
Photograph 25. Westward view of the eastern end of the Wetland Channel showing the backwatering due to Beaver Dam 1 in the background. Photograph taken February 17, 2021.

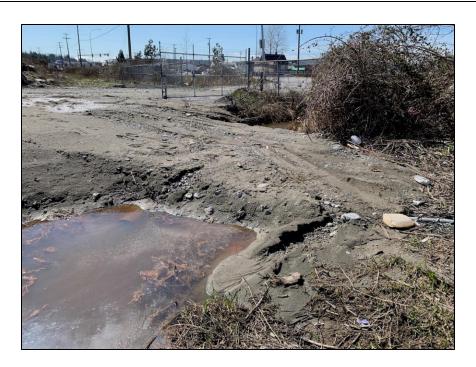
Photograph 27: Southwestern view of the new vehicle crossing located near the downstream end of the Wetland Channel showing the inlet of Culvert 2. Photograph taken April 8, 2021. Note Culvert 2 has since been removed by neighbouring property owner.

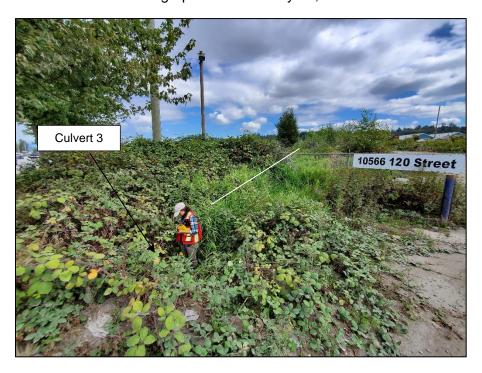
Photograph 30: Eastward view of the Wetland Channel at the inlet of Culvert 3. The white line shows the alignment of the Wetland Channel. Photograph taken September 1, 2020.

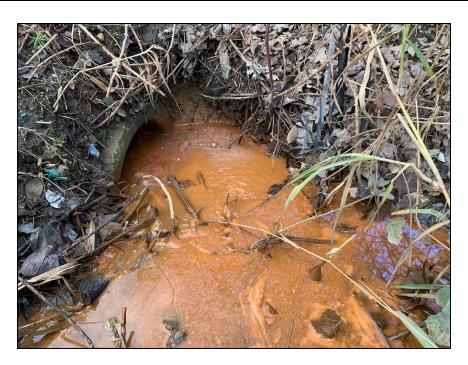
Photograph 31: Inlet of Culvert 3 at the downstream end of the Wetland Channel. Culvert 3 drains into the northern end of Ditch 1. Photograph taken January 19, 2021.

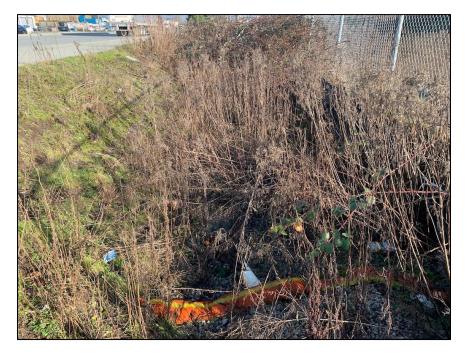
Photograph 34: Northward view of the southern portion of Ditch 1. A catch basin (Culvert 5) is located below the white PVC pipe shown in the foreground. Photograph taken January 19, 2021.

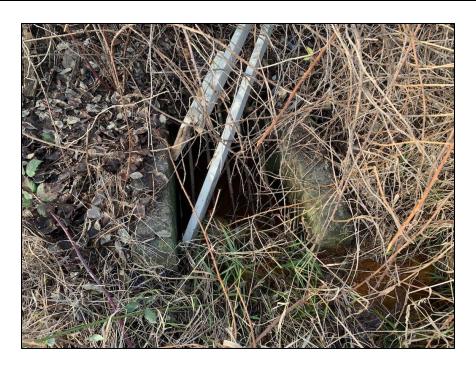
Photograph 35: Westward view of the inlet of Culvert 4 located at the northern end of Ditch 1. Culvert 4 conveys drainage west under Scott Road. Photograph taken January 19, 2021.

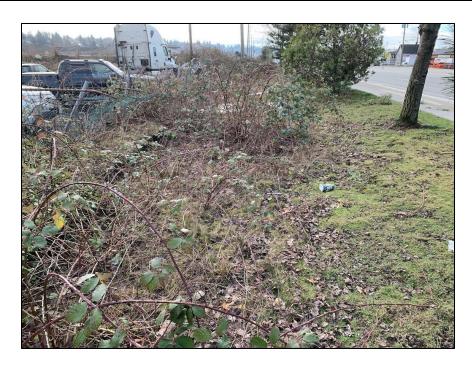
Photograph 37: Southward view of the slight depression along the boulevard west of the central property at 10582 Scott Road. Photograph taken January 19, 2021.

There is essentially no roadside ditch on the east side of Scott Road adjacent to the central property at 10582 Scott Road as well as the southern third of the northern property at 10620/10626 Scott Road. Through this area there is a slight depression between the fenced western property boundary and the grass boulevard, but this would not be considered a ditch and there was no evidence that water collects in this depression (**Photograph 37**).

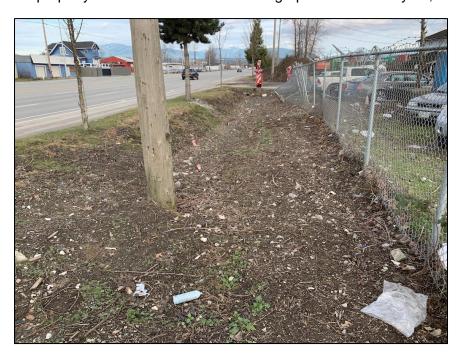
Photograph 38: Northward (downstream) view of Ditch 2 adjacent to the property at 10620/10626 Scott Road. Culvert 6 is in the background under the driveway. Photograph taken January 19, 2021.

Scott Road Ditch 2 is located north of the abandoned southern driveway on the northern property at 10620/10626 Scott Road and the main driveway for that property (**Photographs 38**; **Figure 4**; **and Appendix B**, **Figure AB-16**). This Ditch has been cleared of all vegetation and the inlet of

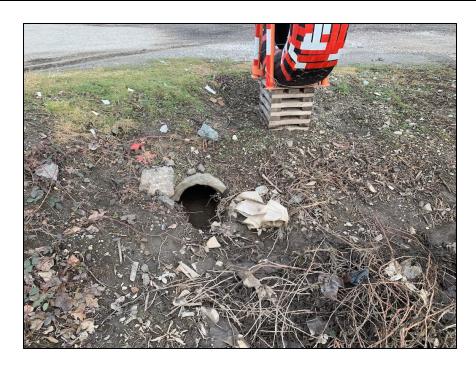
Photograph 39: Northward view of the inlet of the 300 mm diameter concrete pipe (Culvert 6) at the downstream (north) end of Ditch 2. Photograph taken January 19, 2021.

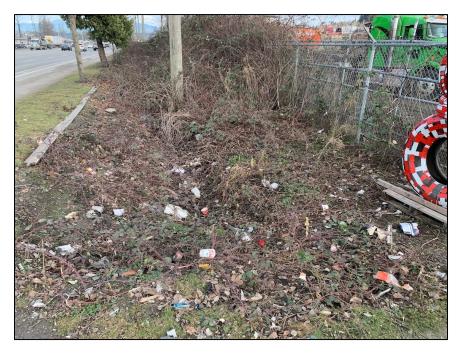
Photograph 40: Northward view of the southern end of Ditch 3. Photograph is taken from Culvert 6 under the driveway for 10620/10626 Scott Road. The outlet of Culvert 6 is buried. Photograph taken January 19, 2021.

Scott Road Ditch 3 is located between the buried outlet of Culvert 6 at the main driveway for the northern property at 10620/10626 Scott Road and the inlet of Culvert 7 at the driveway for the property north of the Site (**Photographs 40 to 42**; **Figure 4**; **and Appendix B, Figure AB-16**), The upstream (south) end of this Ditch has been cleared of all vegetation (Photograph 44) and the rest of the Ditch is occupied with Himalayan blackberry (Photograph 45). Culvert 7 is a 300 mm diameter concrete pipe located under the driveway for the property north of the Site. The inlet of Culvert 7 at the north (downstream) end of Ditch 3 has a trash rack and concrete headwall and wingwalls (**Photograph 42**).

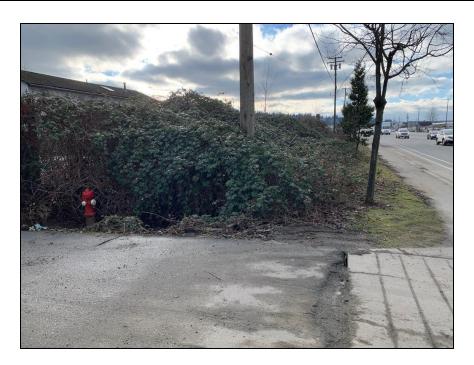
Photograph 41: Southward view of the downstream end of Ditch 3 at Culvert 7 under the driveway for the property to the north of the Site. Photograph taken January 19, 2021.

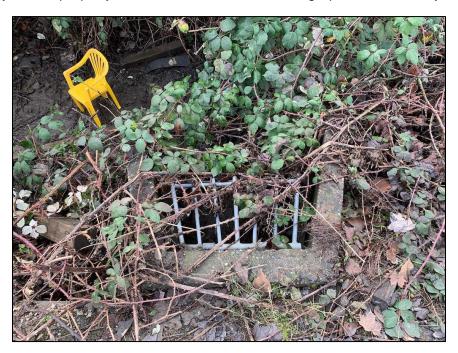
Photograph 42: Inlet of Culvert 7 at the north (downstream) end of Ditch 3 at the driveway for the property to the north of the Site. Photograph taken January 19, 2021.

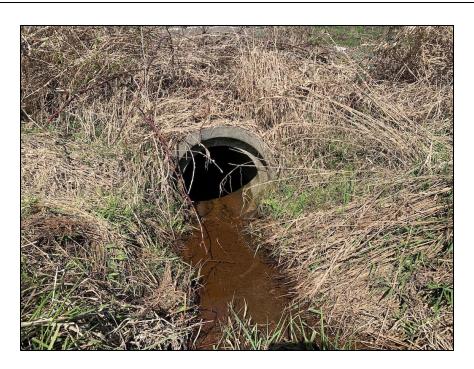
Photograph 43: Northward view of the inlet of Culvert 8 at Old Yale Road which conveys the flow from the Off-Site Wetland Channel. Culvert 8 is a 600 mm diameter concrete pipe.

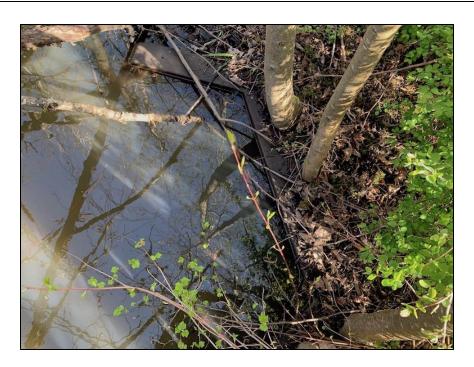
Photograph 45: Outlet of Culvert 9 which is located at the south (upstream) end of the Constructed Habitat Pond situated along the south side of the Off-Site Wetland. Photograph taken April 8, 2021.

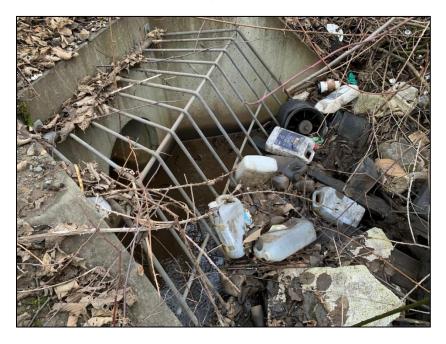
Photograph 46: Inlet of Culvert 10 at the outlet of the Constructed Habitat Pond at the north end of the pond. Culvert 10 is a 600 mm diameter concrete pipe. Photograph taken January 19, 2021.

Along the southern edge of the Off-Site Wetland is a Constructed Habitat Pond located south of the Off-Site Wetland Channel (Photograph 48, **Appendix B, Figure AB-16**). Based on the historical air photos and satellite imagery, the Pond was constructed between 2008 and 2009. As shown on the 2009 air photo (**Appendix B, Figure AB-14**), the recently constructed Pond is 150 m long in the north-south direction and 25 m wide in the east-west direction at its widest point. This pond has a culvert at its inlet at the south end (Culvert 9) and a culvert at its outlet at the north end (Culvert 10) as shown on **Appendix B, Figure AB-16**. The outlet of the south culvert on the pond has a concrete headwall and wingwall and the pipe was submerged during the field assessment (**Photograph 45**). The inlet of the north culvert has a debris rack and concrete headwall and wingwalls (**Photograph 46**).

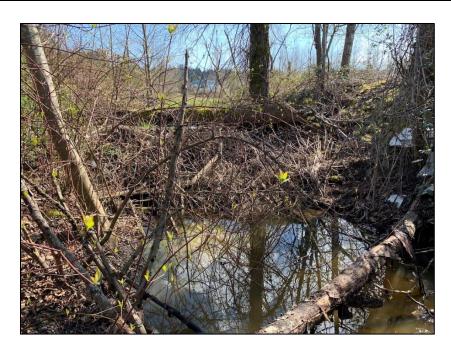
Photograph 47: Northward view of Beaver Dam 2 which is almost 2 m high and located along the Off-Site Wetland Channel 50 m north of Wetland D and adjacent to the inlet of the Constructed Habitat Pond and Culvert 8. Photograph taken April 8, 2021.

A very large nearly 2 m high beaver dam (Beaver Dam 2) is located 50 m north of the northern boundary of Wetland D (**Photograph 47**) on the Off-Site Wetland Channel that flows through the Off-Site Wetland north of the Site (**Appendix B, Figure AB-16**). This dam results in significant backwatering south of the dam on the Off-Site Wetland Channel (**Photograph 48**) and throughout Wetland D (**Photograph 49**). Hence, water levels and drainage in Wetland D appears to be influenced by the presence of Beaver Dam 2. In turn, water levels in Wetland D will affect levels in Wetland C to the south and also affect levels in Wetland B. As discussed earlier, Beaver Dam 1 on the Wetland Channel (**Figure 4**) affects water levels and drainage on Wetlands B and C. Therefore, both Beaver Dams 1 and 2 combine to have a significant impact on drainage within all three wetlands.

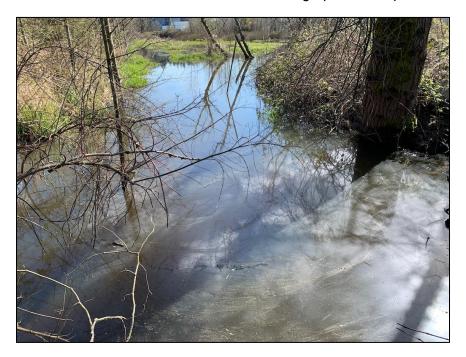
Photograph 48: Southward view from Beaver Dam 2 showing the significant backwatering of the Off-Site Wetland Channel. Photograph taken April 8, 2021.

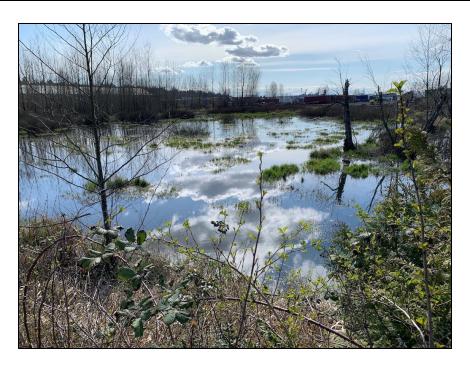
Photograph 49: Southward view from near Beaver Dam 2 showing the significant backwatering of Wetland D due the dam. Photograph taken April 8, 2021.

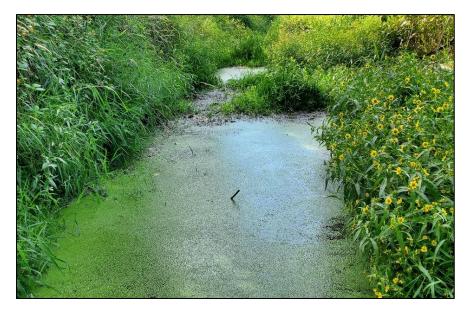
Photograph 50: View looking west of the isolated wetted area in the Wetland Channel on September 8, 2021.

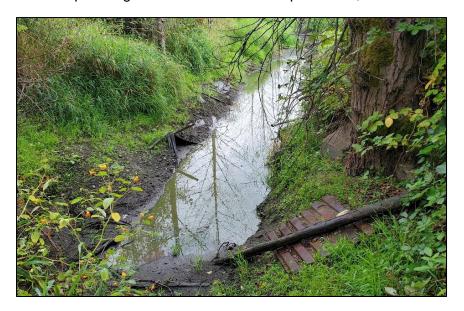
Photograph 51: View looking east of the isolated wetted area in the Wetland Channel during dip netting efforts conducted on September 8, 2021.

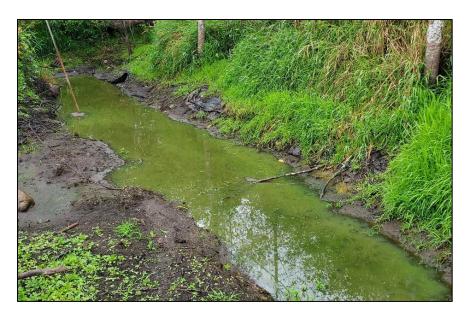
Photograph 52 View looking south of the isolated wetted area northwest of Wetland D on September 8, 2021.

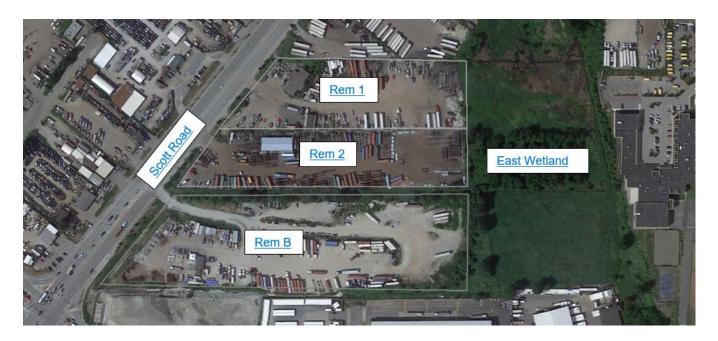
Figure 1 Location of Features around Proposed Development

A hydrologic analysis was completed to support stormwater management concepts for the project site. The proposed development of the project site will result in changes to runoff patterns and will include the infilling of a drainage channel located between properties Rem 2 and Rem B, the location of which are shown in Figure 1. The hydrological analysis and subsequent hydraulic analysis were completed to assess the changes to runoff conditions and provide recommendations on future drainage management. Currently the site drains primarily in two directions, towards the wetland to the immediate east of the proposed development and to the west along the drainage infrastructure along Scott Road. Based on the survey completed for this project, drainage from the channel between Rem 2 and Rem B primarily flows to the southwest with sections of Rem 1 and possibly Rem 2 draining towards the north. A fourth drainage path includes ditches lining the southern side of Rem B which drain into a culvert at 122^{nd} Street.

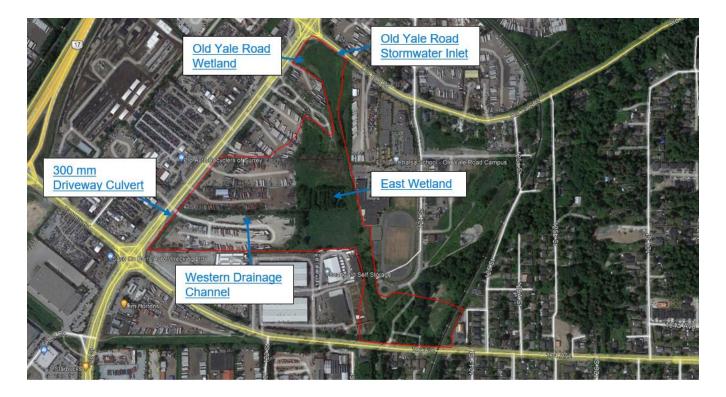
Figure 2 Estimated catchment area at Old Yale Road stormwater inlet post-development outlined in red

Based on design standards issued by the City of Surrey as detailed in their Engineering Department's Design Criteria Manual, drainage works for the subject property would be required to pass the 5-year storm event under free flow conditions. Further, stormwater from the property must be managed to control the 5-year post-development flow to 50% of the 2-year post development rate or control the 5-year post-development flow to 5-year pre-development flow rate. The purpose of this report is to provide clarity on the stormwater interactions with the wetland while the onsite drainage plan is to be undertaken by others.
